O & M INSPECTION REPORT FOR NAVIGATION PROJECTS
Honolulu Engineer District
CEPOH-EC-T

1. Project Name: Tau Harbor
2. Date of Inspection: March 8, 2005
3. Inspection Personnel:

There is a need to perform general maintenance at the project. This maintenance is primarily vegetation removal from the revetment and groin, removal of encroachments from the breakwater and repairs to the root of the revetment and the head portion of the groin.

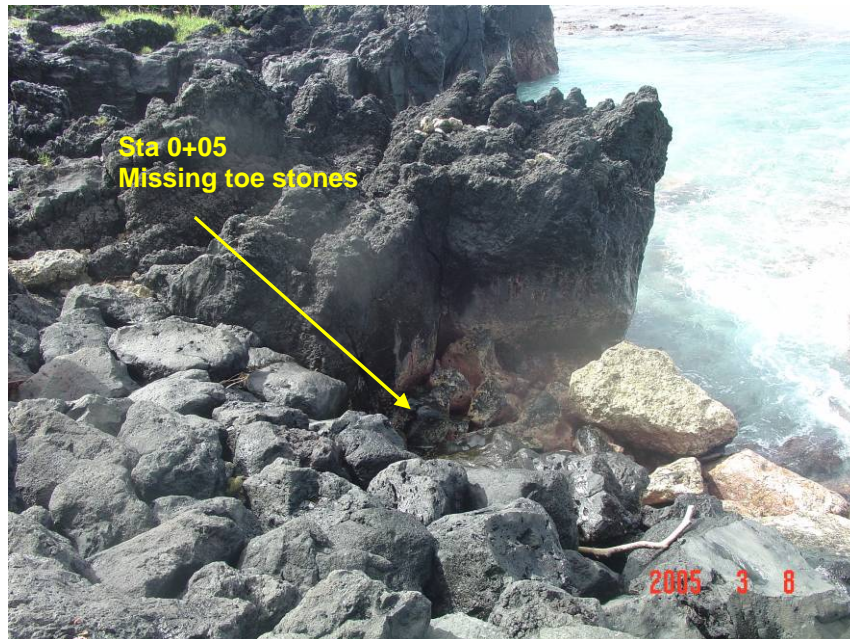
a. Sta. 0+05, two or three armor stones missing from toe of revetment near structure root, minor stone movement since 2003. Continue to monitor this area.

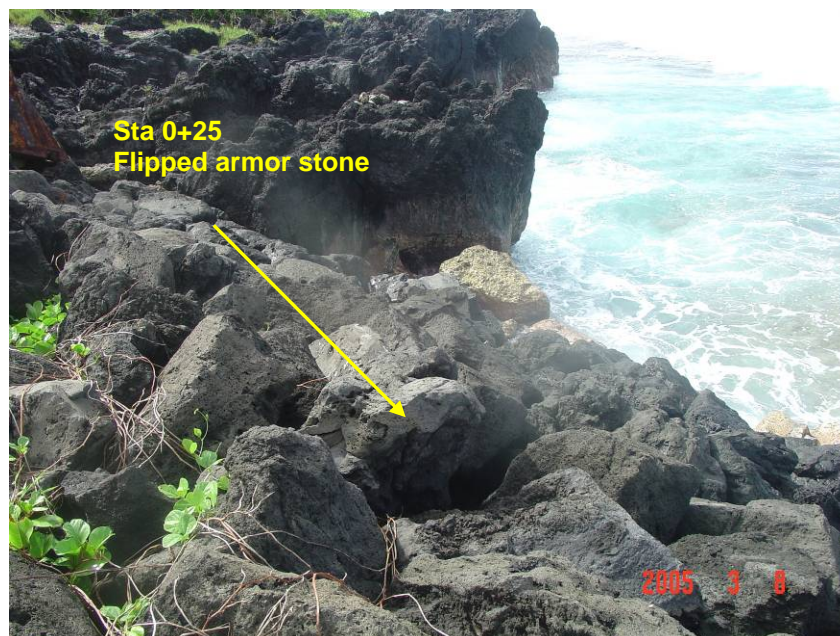
b. Sta. 0+25, 1 ea. flipped armor stone at the hinge, no recent change, continue to monitor.

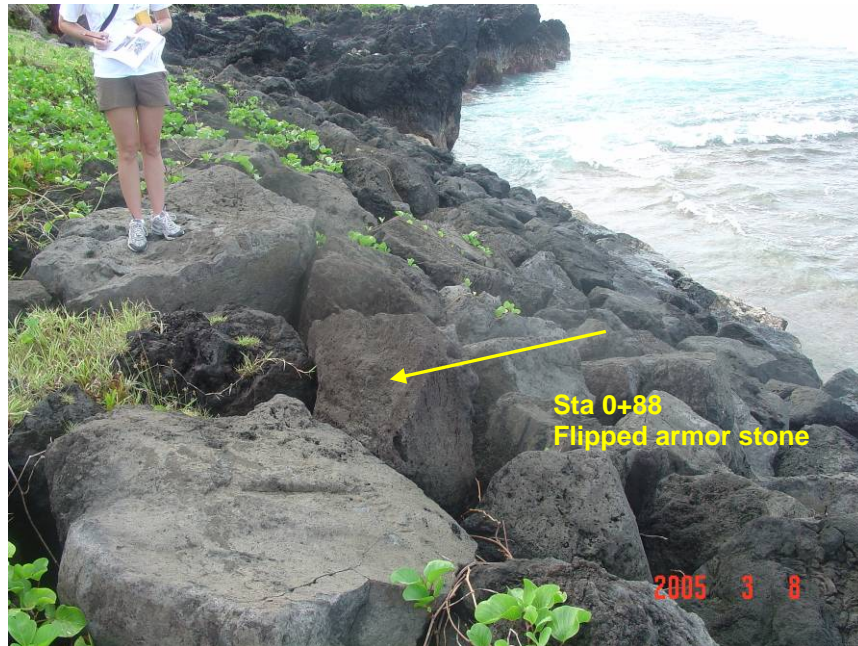
d. Sta 0+88, 1 flipped stone at crest hinge, new this inspection, monitor.

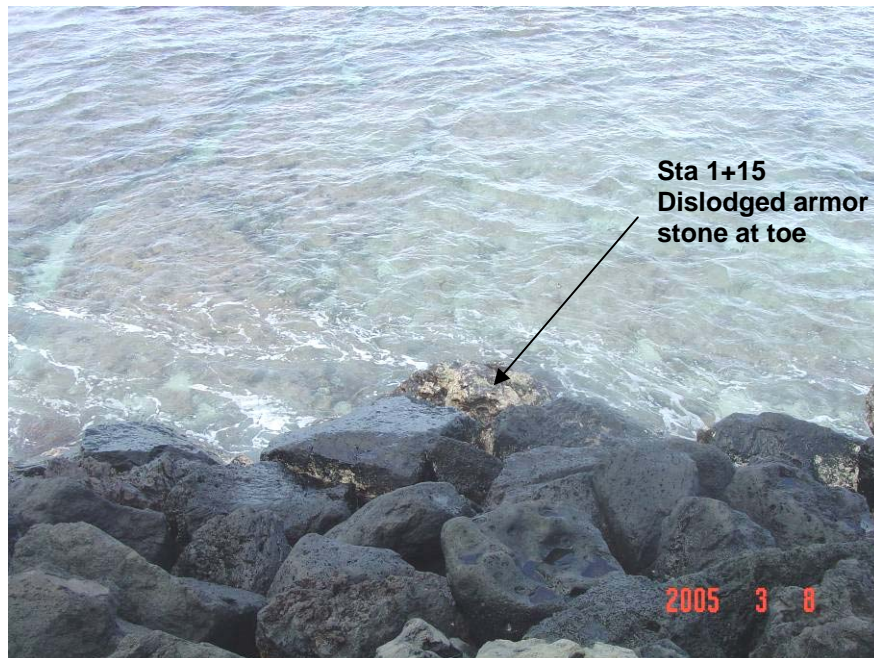
e. Sta. 1+15, 1 each dislodged armor stone at toe, no void observed. No change since 2003 inspection, continue to monitor.

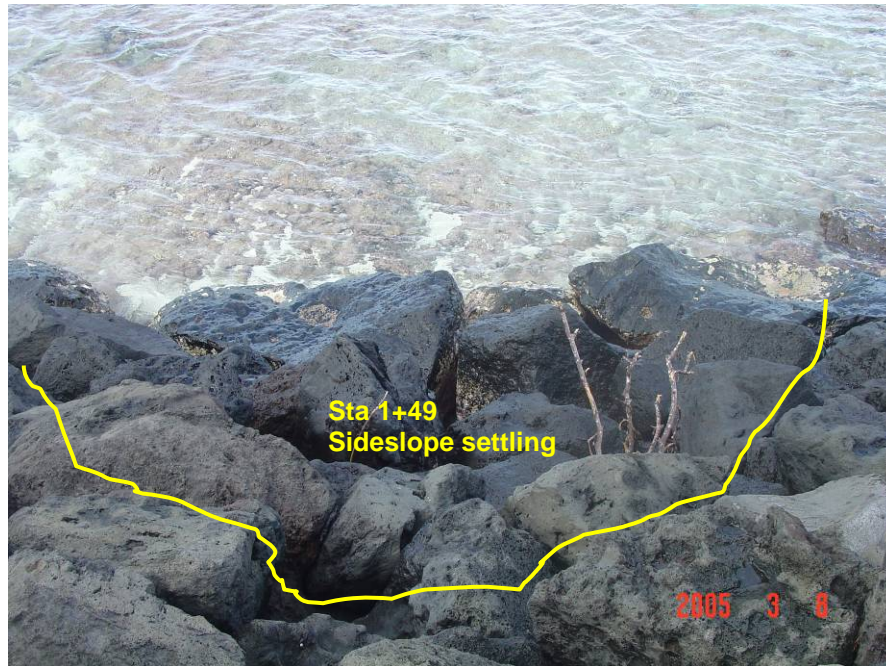
f. Sta. 1+49, 20'x20' area of settling on side slope. No change since 2001 inspection. Continue monitoring.

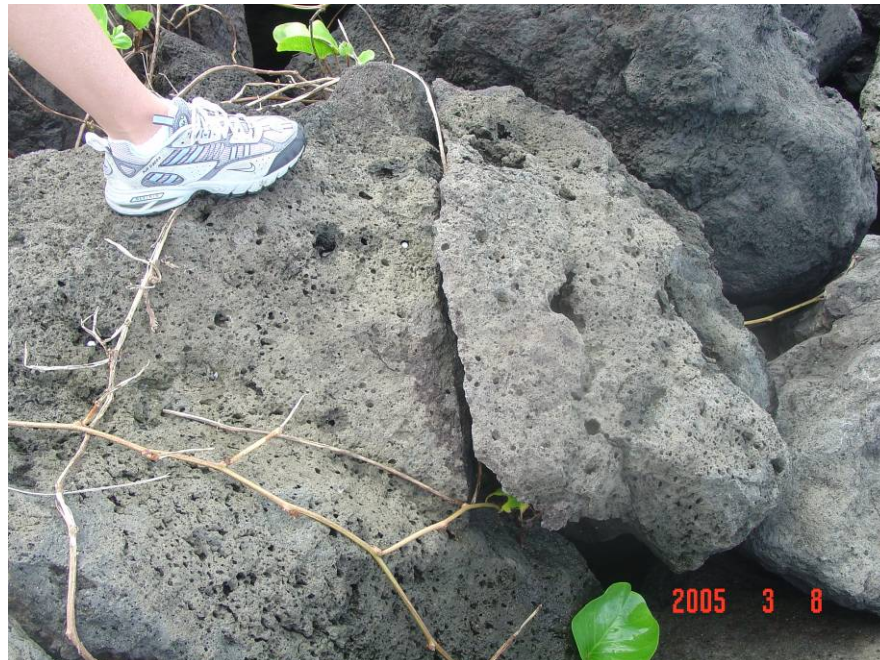
g. Sta. 1+49, Cracked armor stone on crest, first noted this inspection.

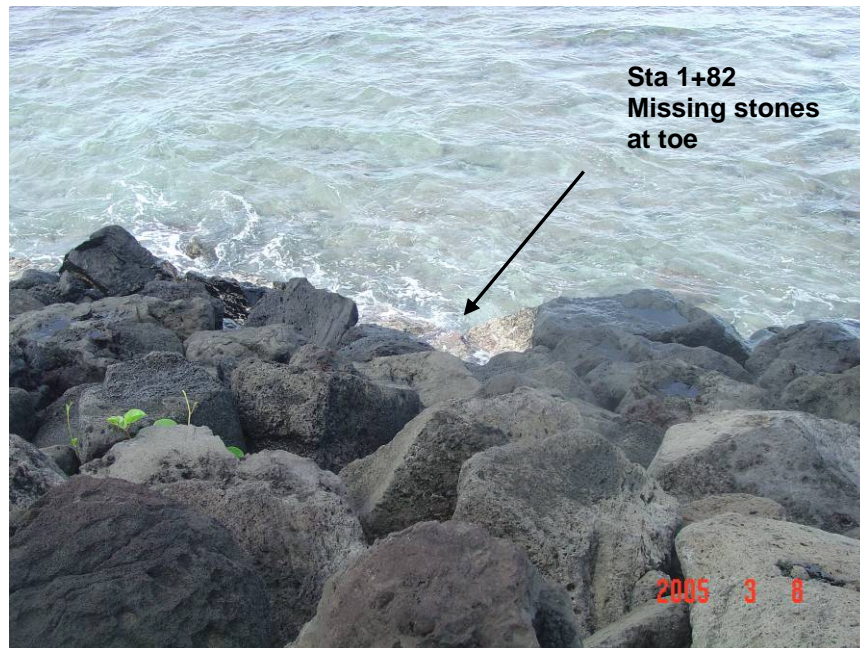
- i. Sta. 1+82, Monitor 1 ea. flipped armor stone and settling of the sideslope. Possible missing stones at toe noted during this inspection.

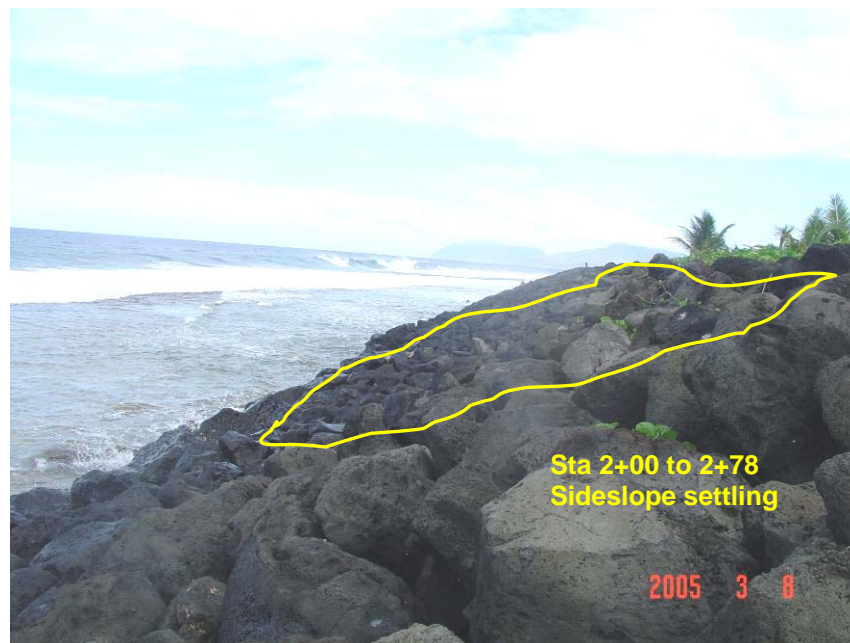
- j. Sta. 2+00 to 2+78, sideslope settling from crest to toe. First noted in 2003, continue to monitor closely.

Observed Damage Level - Fair-Poor, Some deterioration to the structure and defects such as encroachment and vegetation overgrowth are evident, but function is not significantly affected. Particular attention should be paid to stations 1+49 and 2+00 to 2+78 where the revetment sideslope is flattening/settling, and to the head portion of the breakwater where there are several dislodged toe armor stones.

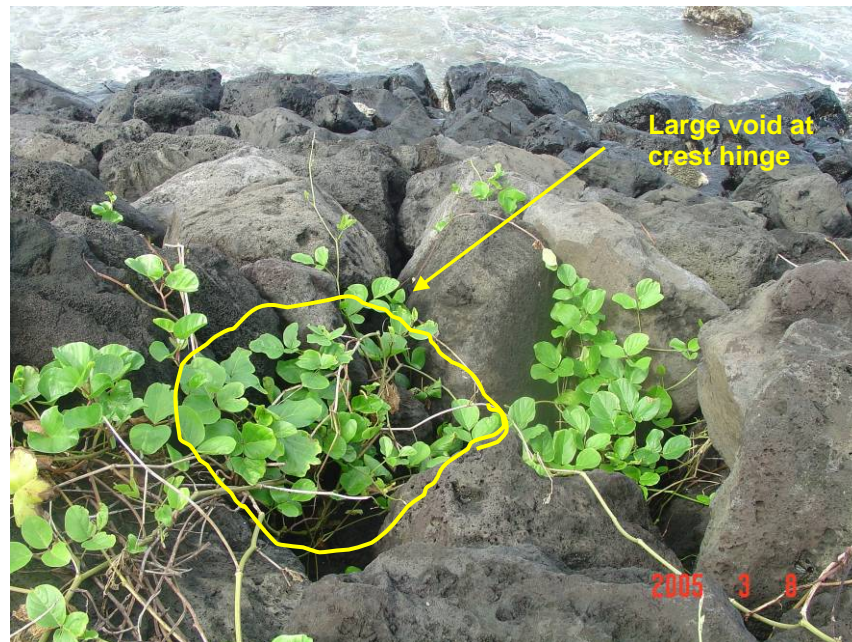
k. Sta. 2+05, Large void at crest hinge, monitor.

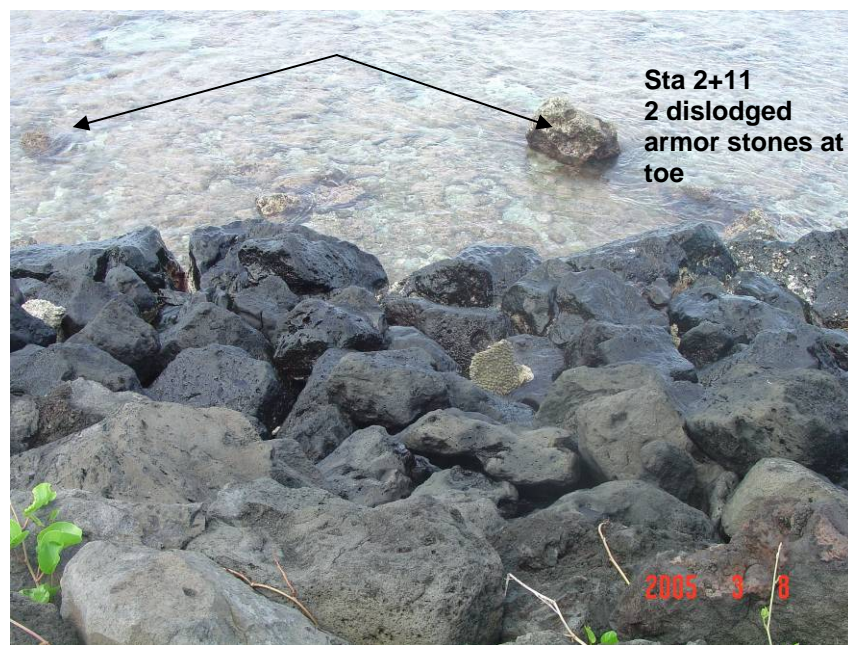
l. Sta. 2+11, two armor stones dislodged at toe.

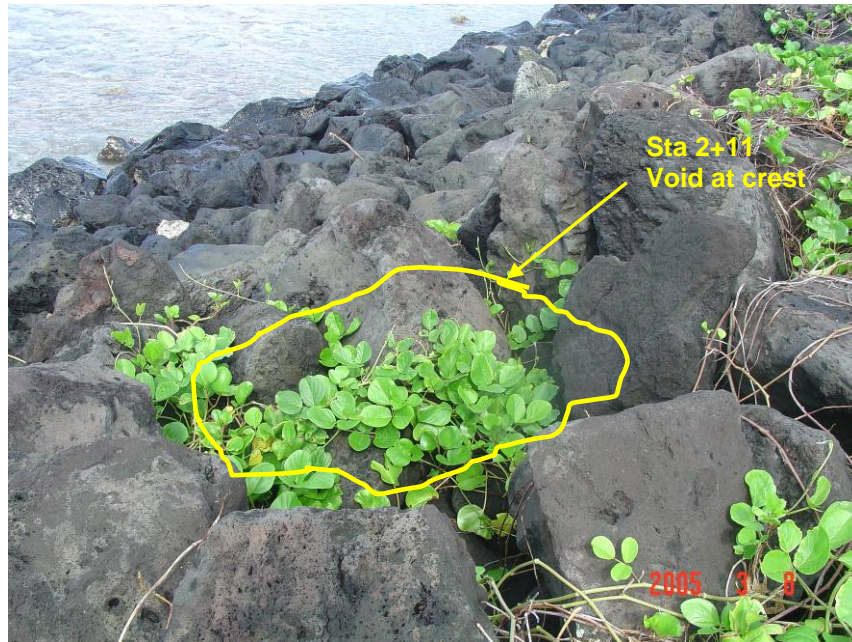
m. Sta. 2+11, Void on crest, possible previous location of dislodged stone at toe.

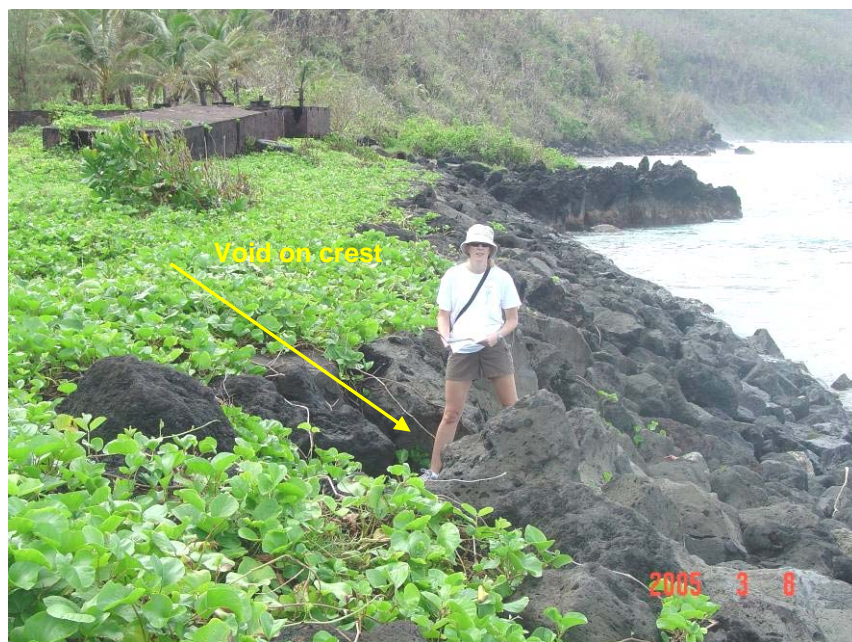
n. Sta. 2+49, Large void on crest, reset with armor stone.

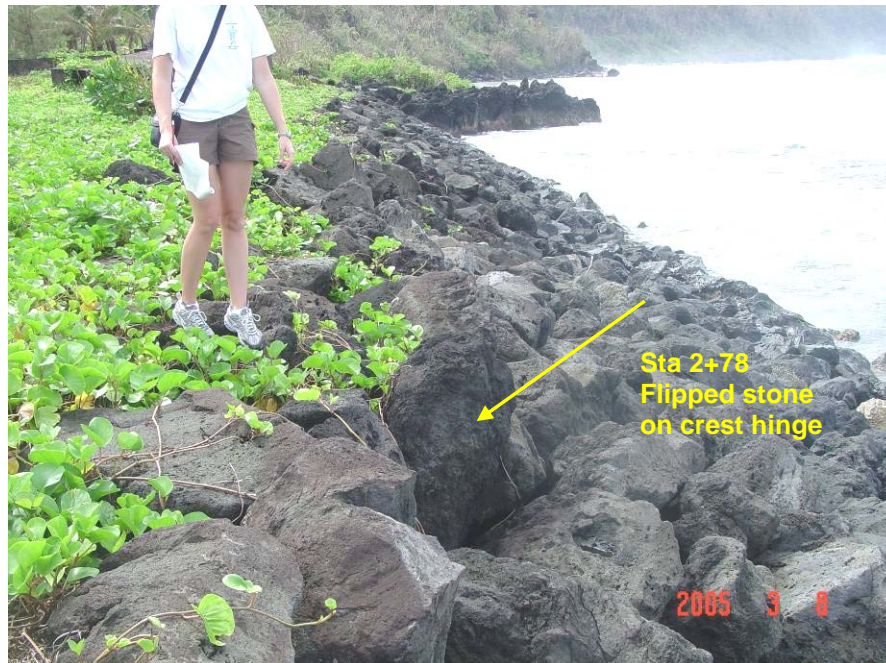
o. Sta. 2+78, End of sideslope settling area, flipped armor stone on crest at this location as well.

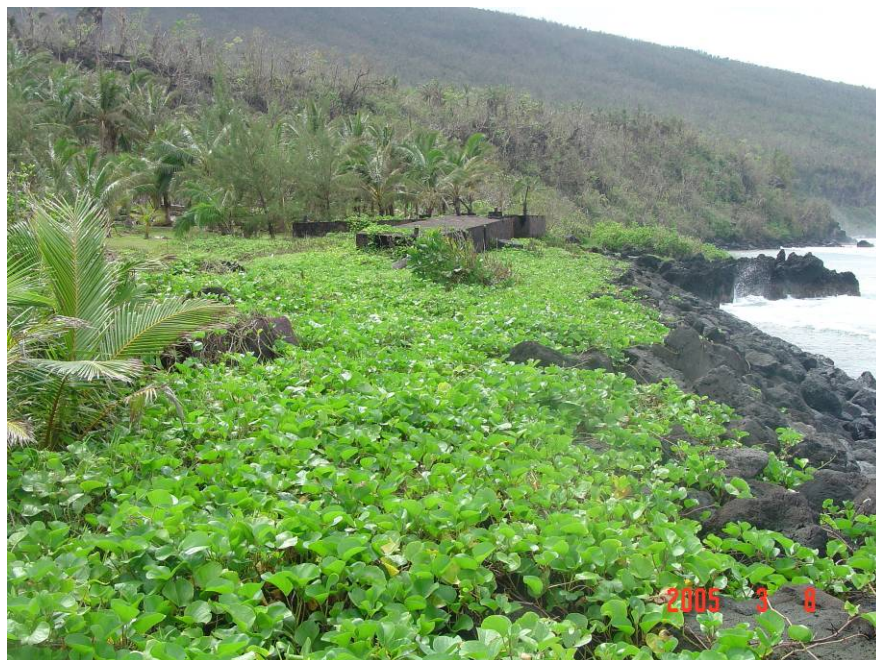
p. Sta. 2+78, Overview of settling area, significant vegetation growth on crest since 2003 inspection, remove with herbicide.

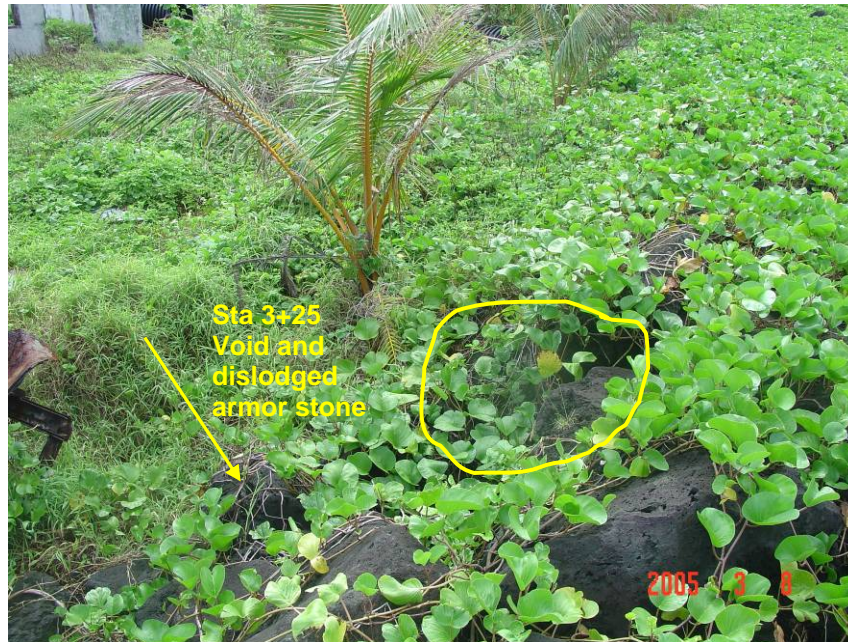
- q. Sta. 3+25, HS, Monitor 1 ea. missing armor stone at the hinge w/large void. Stone has rolled back from crest.

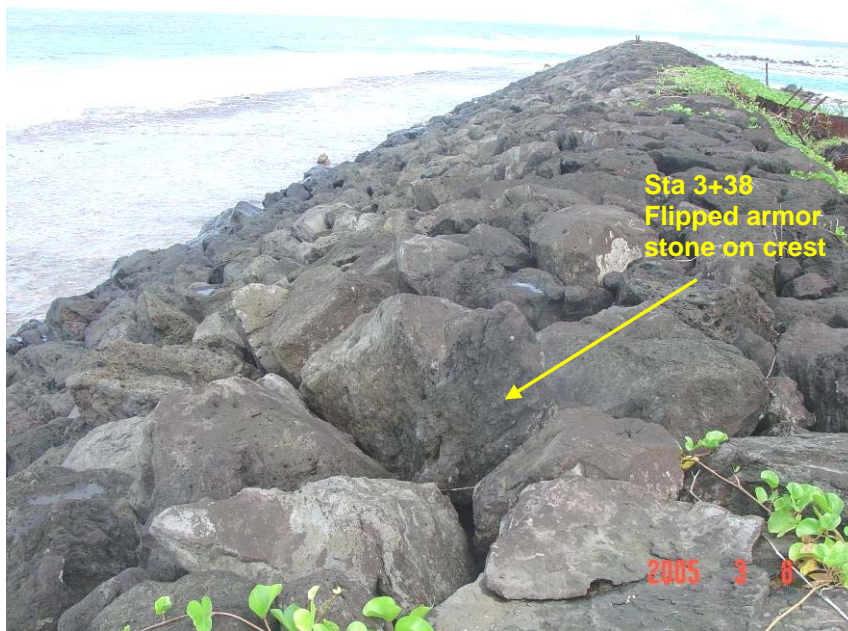
- r. Sta. 3+38, Flipped armor stone on crest, monitor.

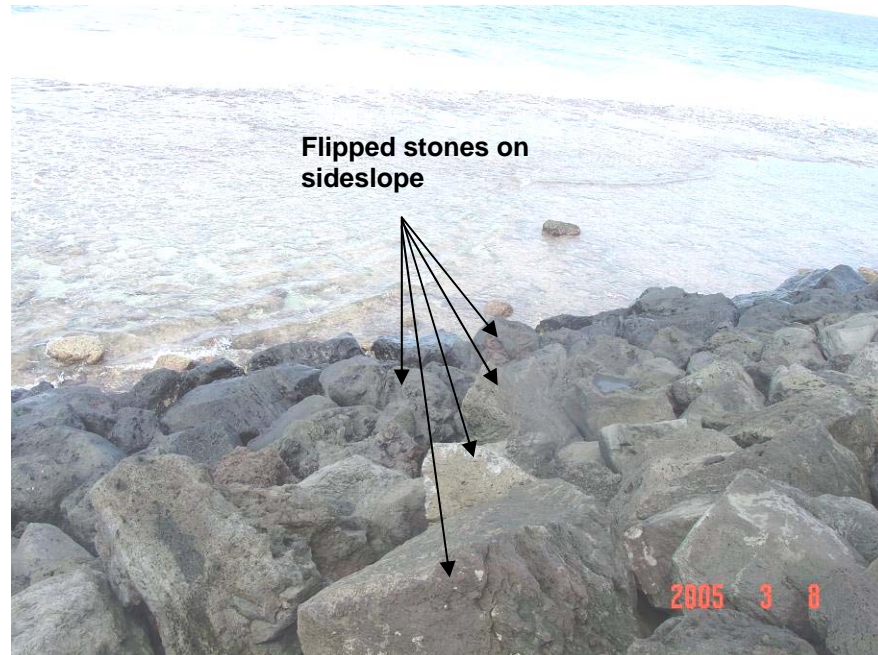
s. Sta. 3+50, minor settling of crest, 5 ea. armor stones "flipped" and void on the sideslope. Some movement since 2003, monitor.

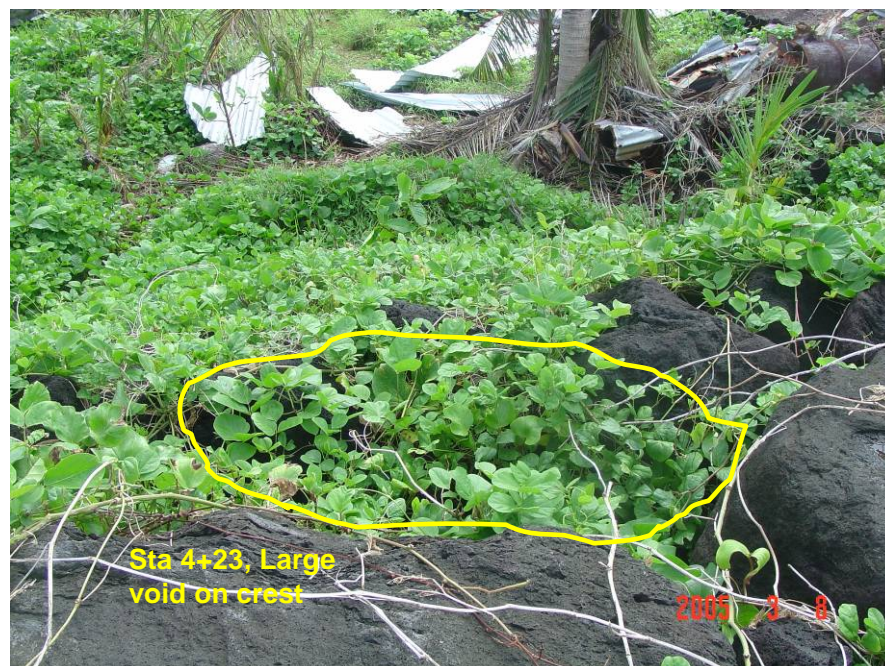
a. Sta. 4+23, HS, hinge, void in crest, 6'x 2'x3'deep. Reset stone.

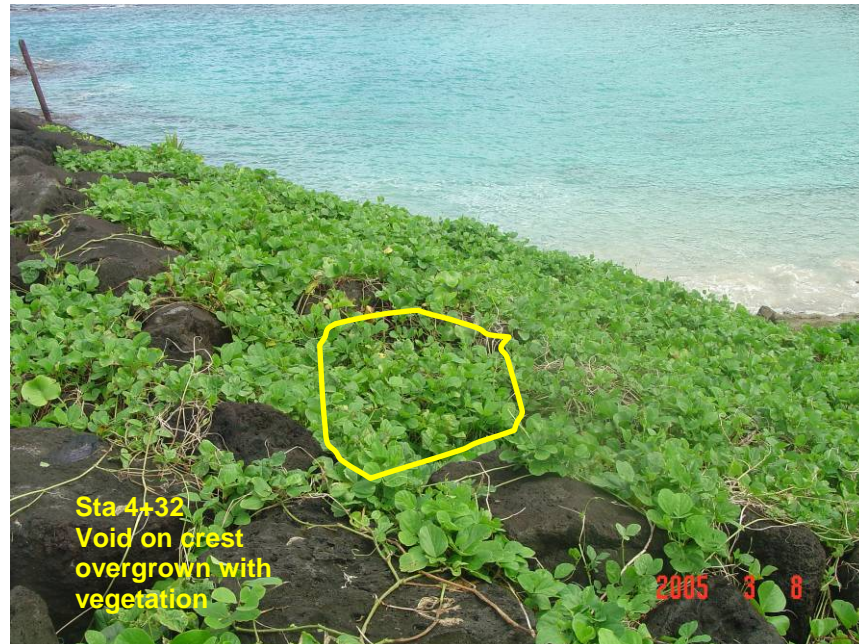
b. Sta. 4+32, HS, hinge, void at crest filled with vegetation. Remove vegetation along this area and replace armor stone.

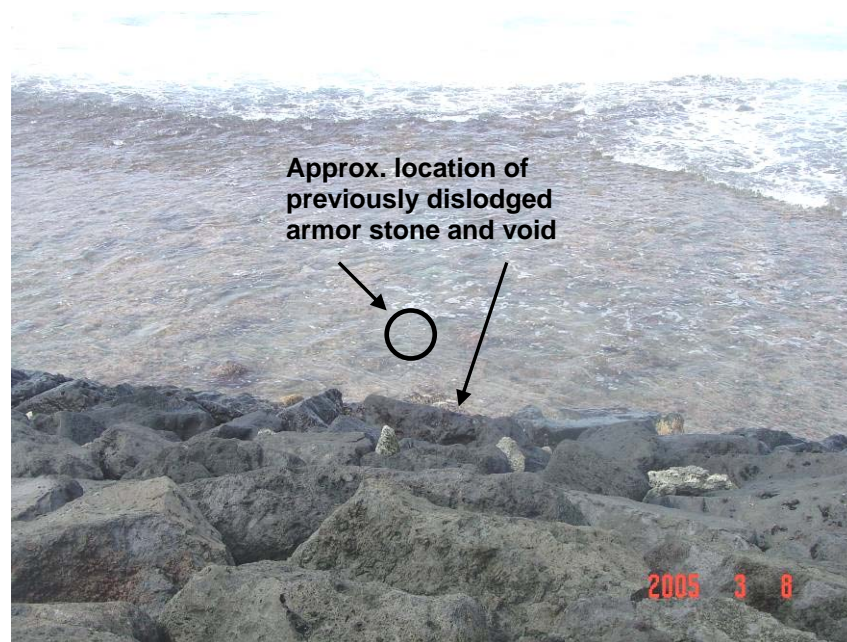
d. Sta. 5+32, OS, 1 armor stone dislodged and resting 4' from toe in 2003 is now gone. Void created from dislodged armor stone.

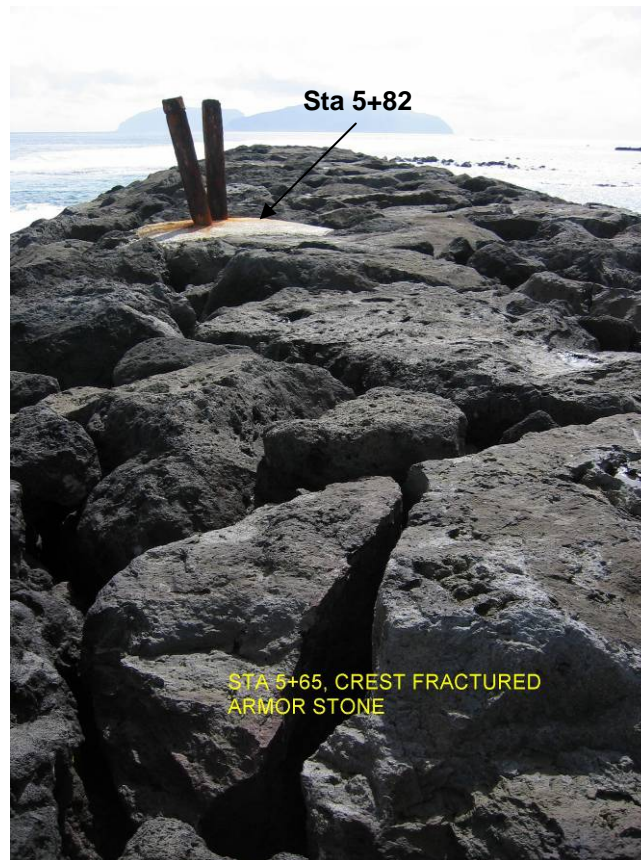
e. Sta. 5+65, Crest, 1 fractured armor stone. Sta. 5+82, metal pipes. (2003 Photo)

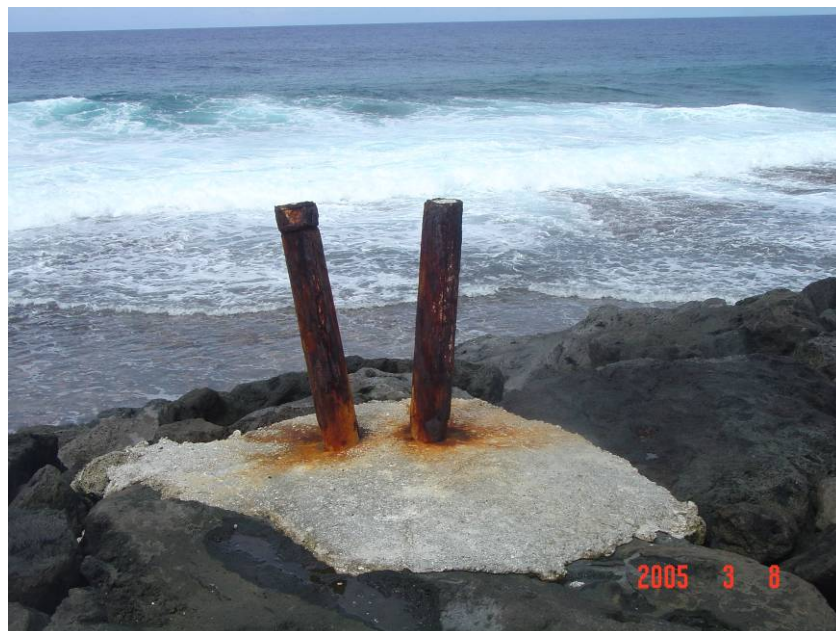
f. Sta 5+82, metal pipes set in concrete used as moorings. Remove from structure.

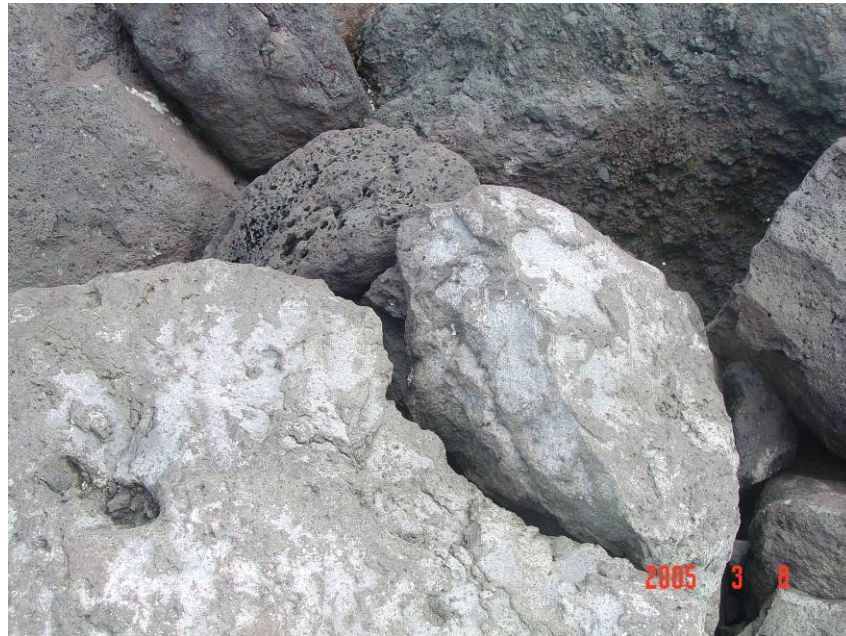
g. Sta 5+93, Cracked armor stone on crest, new this inspection.

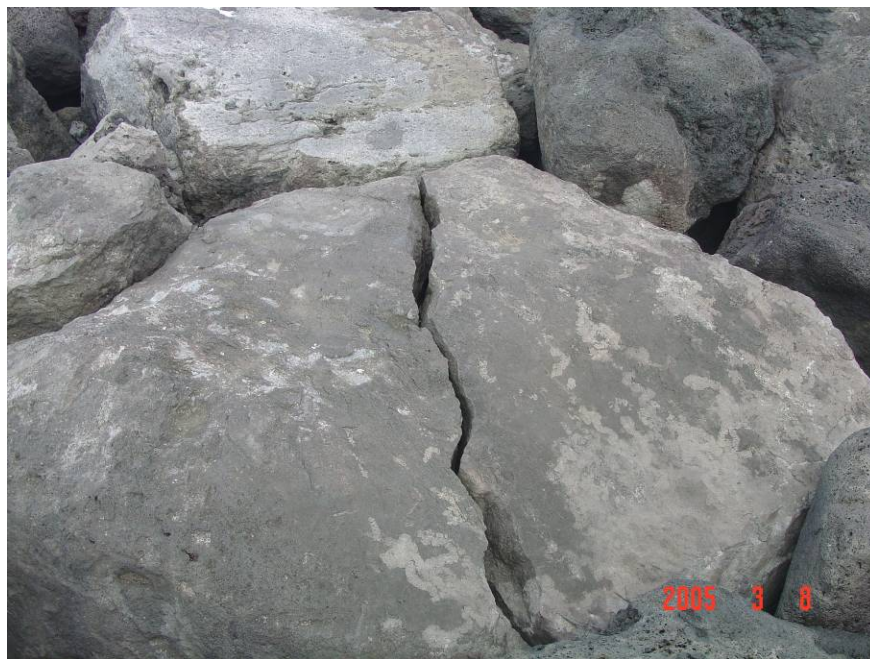
f. Sta. 6+14, Crest, 1 fractured armor stone, noted in 2003 inspection.

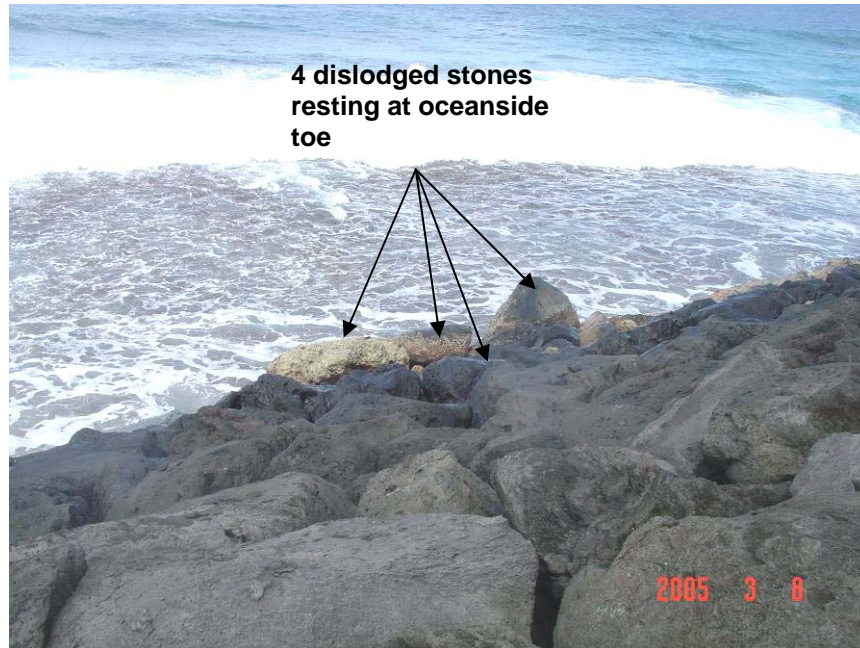
g. Sta. 6+33, OS, four armor stones resting at the toe, possibly dislodged from head area (Sta.7+40, OS).

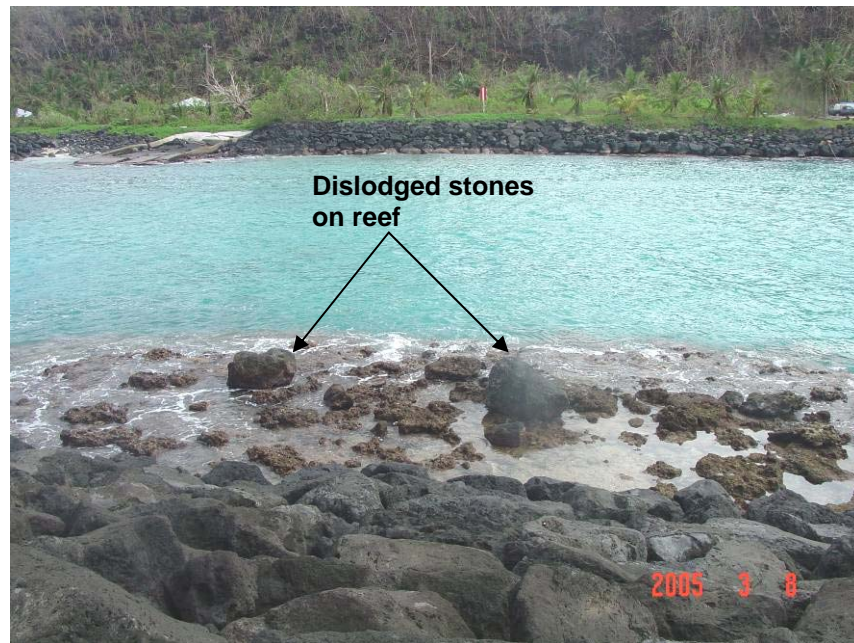
h. Sta. 6+46 and 6+67, HS, 2 dislodged armor stones resting on reef at toe.

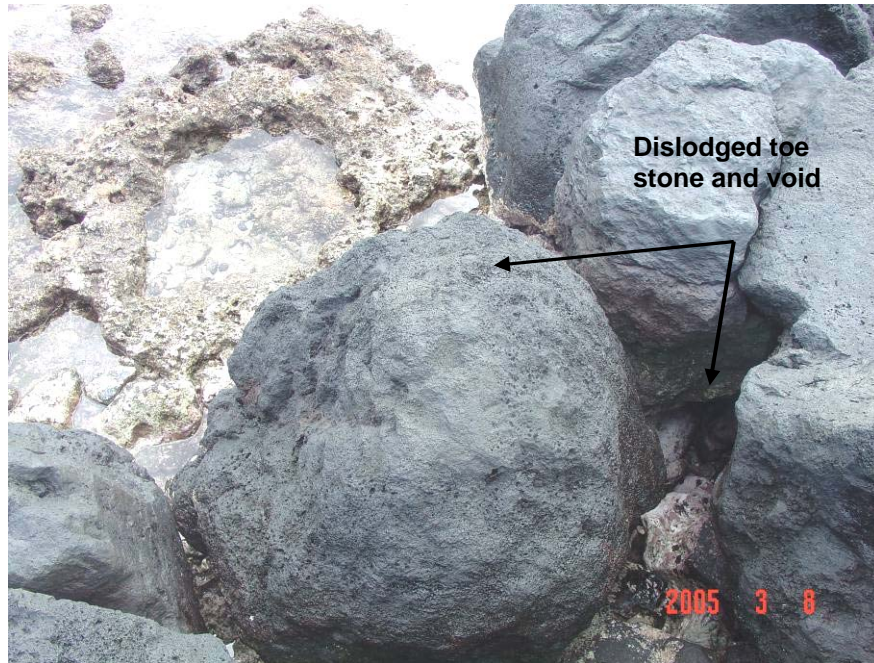
i. Sta. 6+67, HS, 1 dislodged armor stone and void at toe.

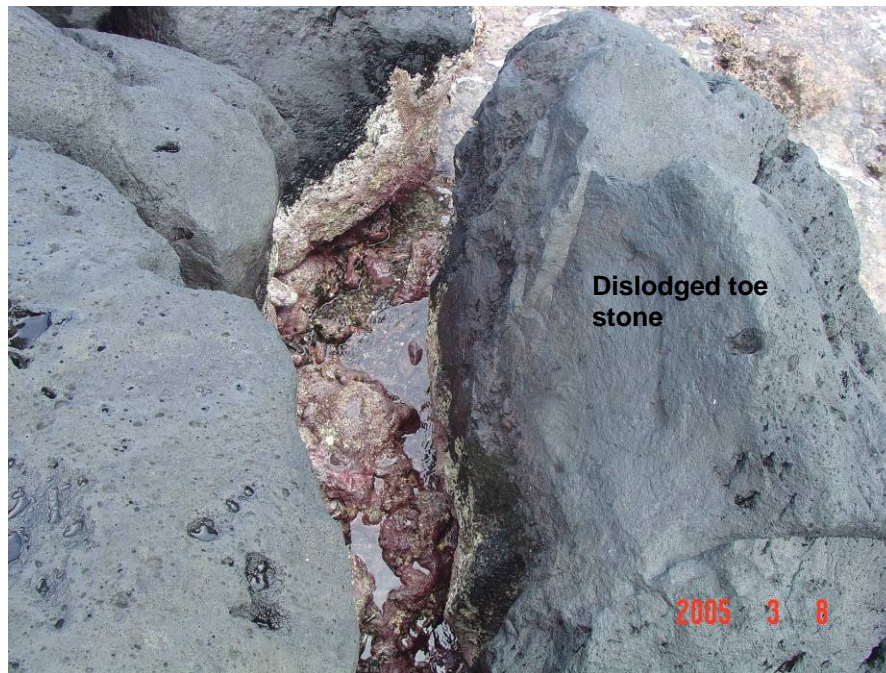
j. Sta. 6+75, HS, 1 dislodged toe armor stone. Sta. 7+04, end breakwater.

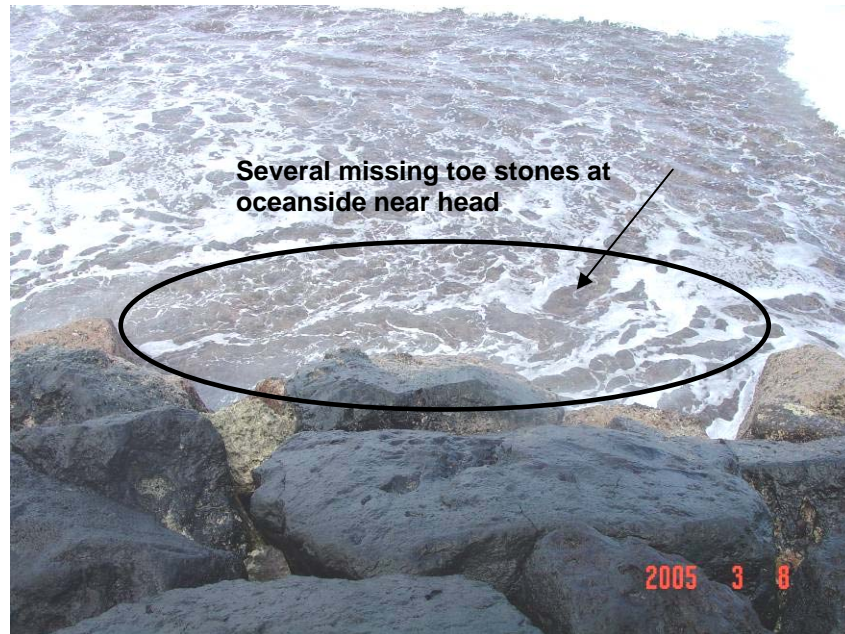
k. Sta. 6+95, OS, 20LF of toe armor stone is missing.

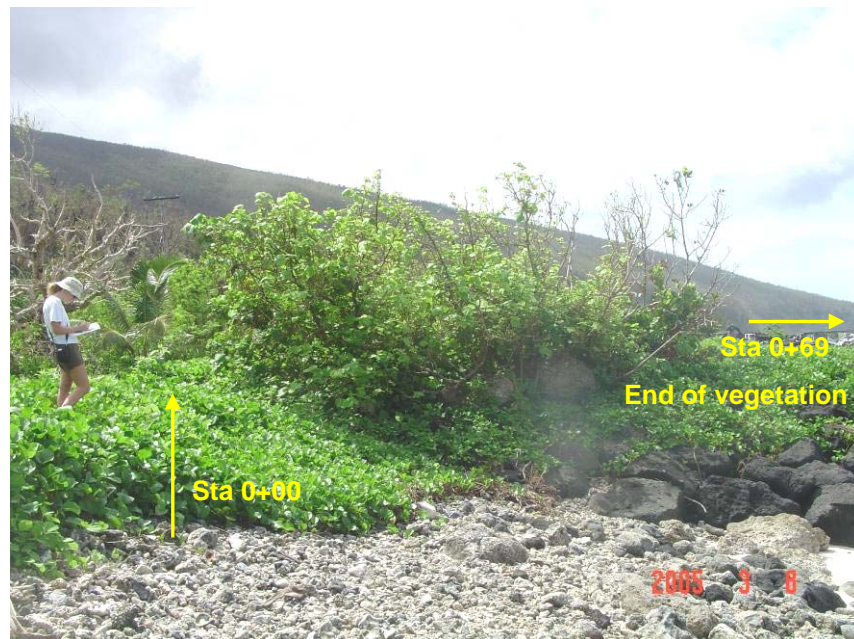
a. Sta. 0+00, to 0+69, The vegetation continues to thicken and creep further onto the root of the structure. Remove tree and vegetation growing on structure.

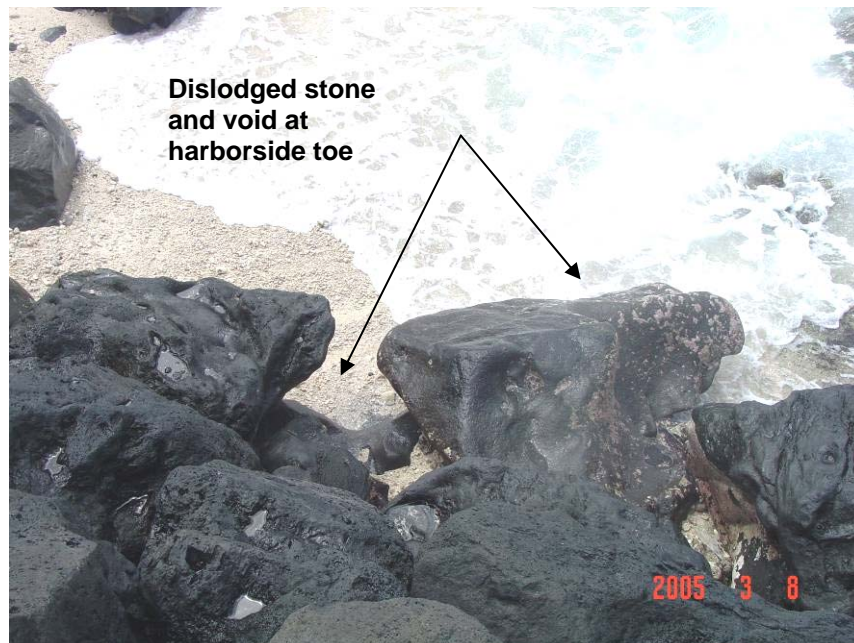
b. Sta. 0+94, HS, 1 dislodged armor stone and void at toe, reset stone.

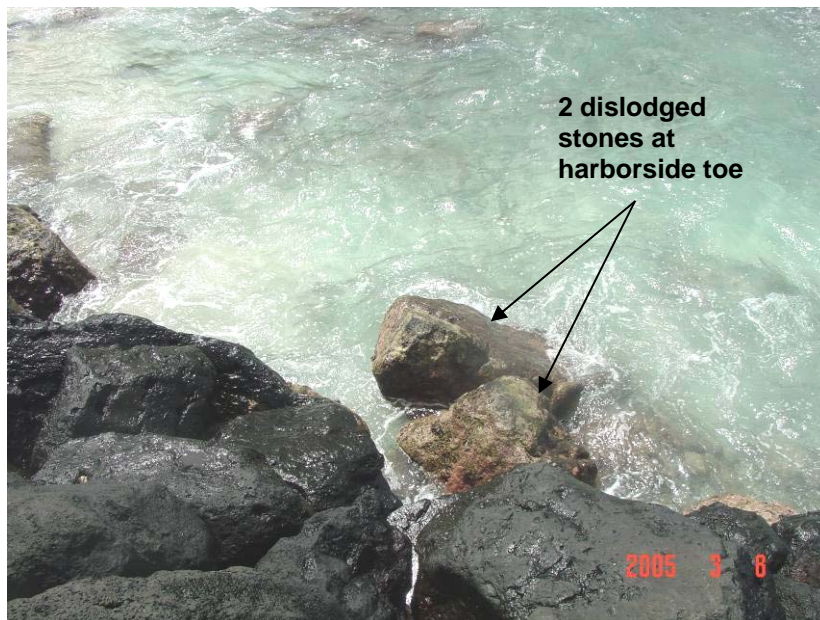
c. Sta. 1+24, HS, two dislodged toe stones. Monitor. Also a cracked armor stone on crest, and 1 ft separation at HS hinge with some sliding of stones on sideslope, new this inspection. Monitor closely.

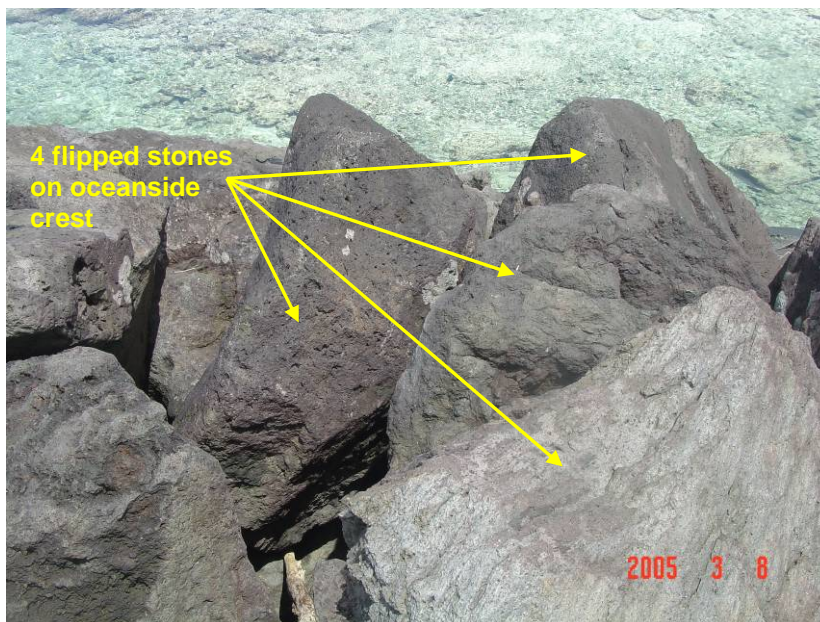
d. Sta. 1+36, OS crest, four flipped armor stones and small void.

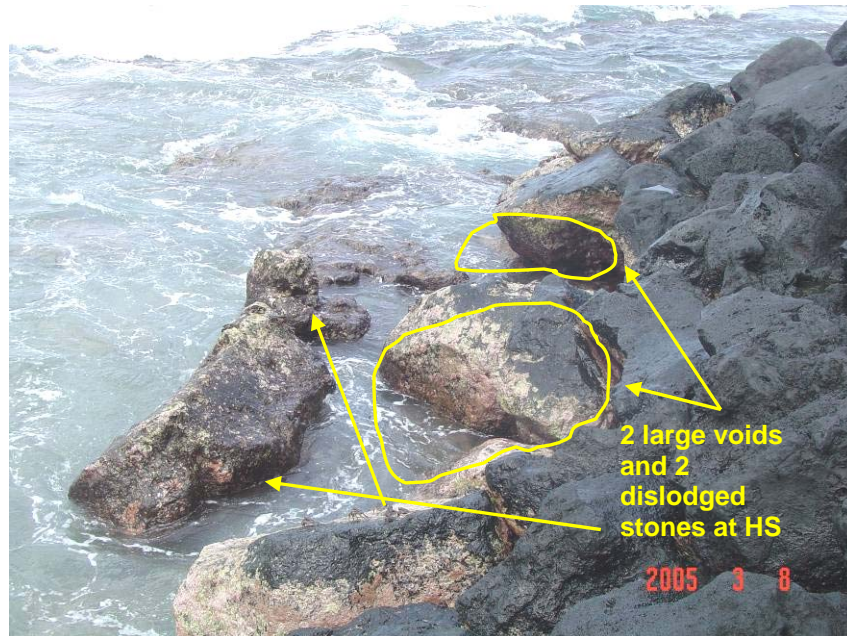
- e. Sta. 1+66, HS, 2 large voids at toe, 2 dislodged stone resting at toe.
Monitor this area.

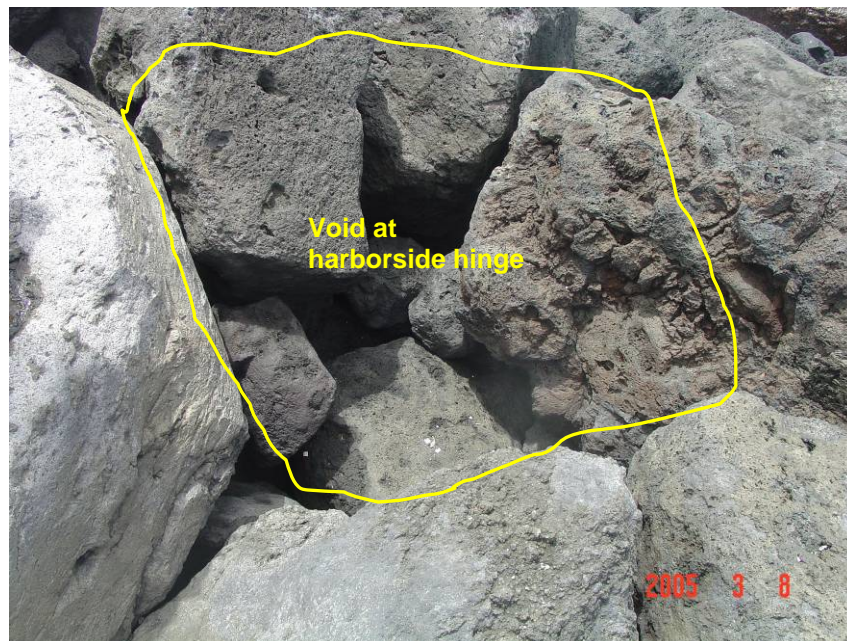
- f. Sta. 1+66, HS, 1 void at harborside hinge, monitor.

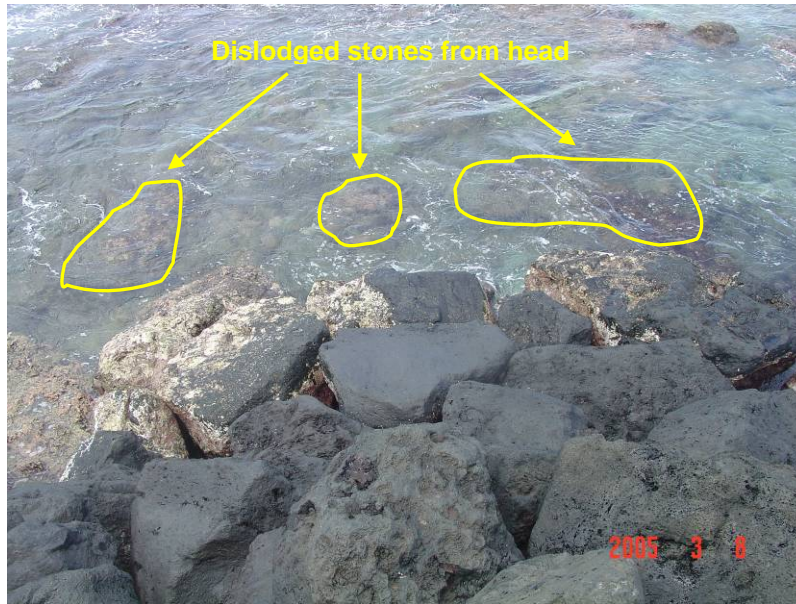
h. Sta. 1+89, Dislodged armor stones at head.

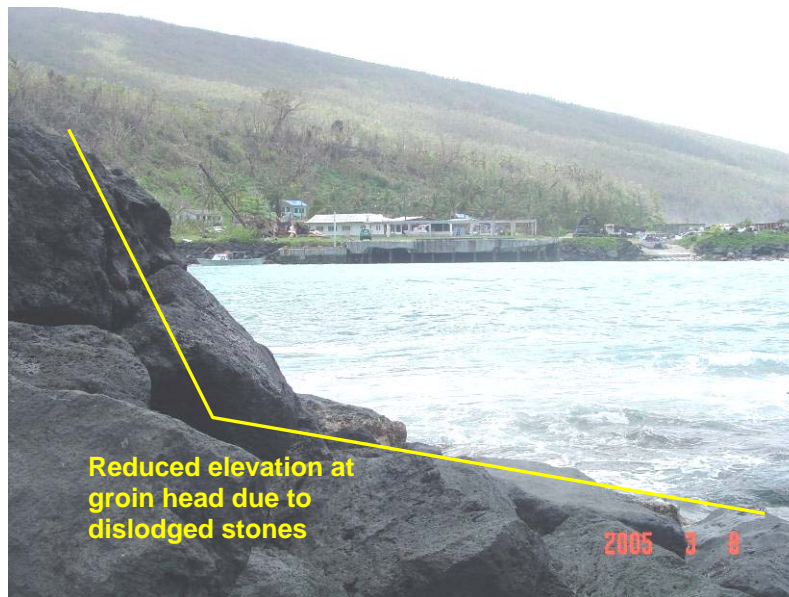
i. Sta. 1+89, profile view of missing armor stones at head. Head "steps" down to a lowered elevation at its oceanward extent. Monitor this area closely for continued damage.

Observed Damage Level, Fair, Some deterioration or defects are evident, but structural function is not significantly affected. Particular attention should be paid to the head portion at station 2+00, where there are multiple dislodged stones and noticeable changes to the slope of the structure at its head.
